Manhole Inspection Summary

Manhole # S65I__028MH

Record Plat: **651** Node: **028** Status: **New Manhole (Not in GIS)** Insp Date: **1/15/08 9:00 AM**

Location Address: **535 Dundalk Ave.**

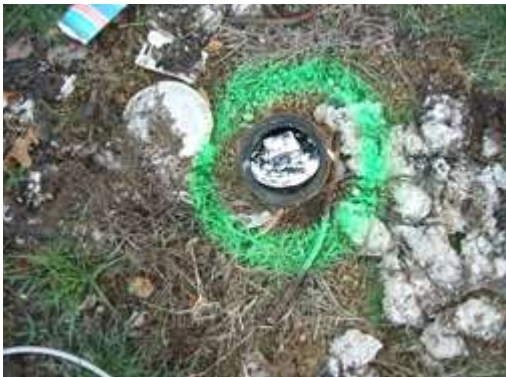
Defect 1

Comments **CLEAN OUT APPROX. 3 FEET FROM MANHOLE IS DAMAGED. MANHOLE RENAMED FROM S65I__A02MH [03162009] RS**

Damaged cleanout approx 4 feet from MH.

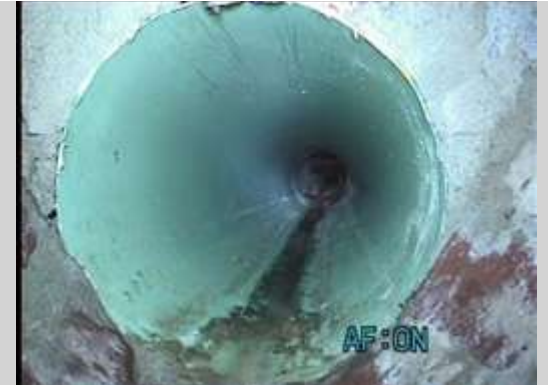
12 O'Clock Outflow

8 in. Circular Gravity Sewer
Pipe Out @ 12 O'Clock

Pipe Height: **8.4** (in.) Rod and Bar (Angled)
Pipe Material: **PVC** ☐ Pipe Lined
Invert Depth: **7.83** (ft.) Flow Characteristics: **Slow**
Deposits: ☒ None ☐ Mud ☐ Sludge ☐ Debris ☐ Grease
Silt Depth: (in.) Deposits Extent:
Infiltration: **None** Pipe Seal Cond: **Sound**

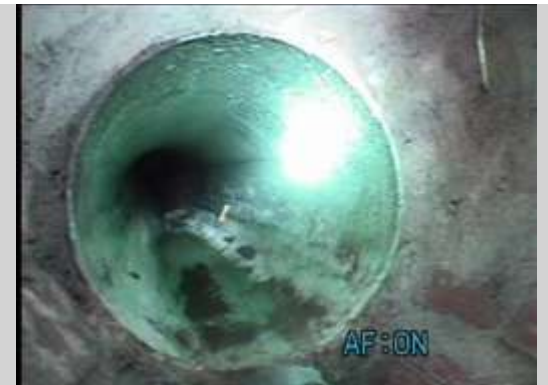
6 O'Clock Inflow

8 in. Circular Gravity Sewer
Pipe In @ 6 O'Clock

Pipe Height: **8.4** (in.) Rod and Bar (Angled)
Pipe Material: **PVC** ☐ Pipe Lined
Invert Depth: **7.83** (ft.) Flow Characteristics: **Slow**
Deposits: ☒ None ☐ Mud ☐ Sludge ☐ Debris ☐ Grease
Silt Depth: (in.) Deposits Extent:
Infiltration: **None** Pipe Seal Cond: **Sound**
